CANMET Gasifier Liner Coupon Material Test Report

TOPICAL REPORT

Task 1 Cooled Liner Coupon Development and Test

**Pratt & Whitney Rocketdyne, Inc.
6633 Canoga Avenue
P.O. Box 7922
Canoga Park, CA 91309-7922**

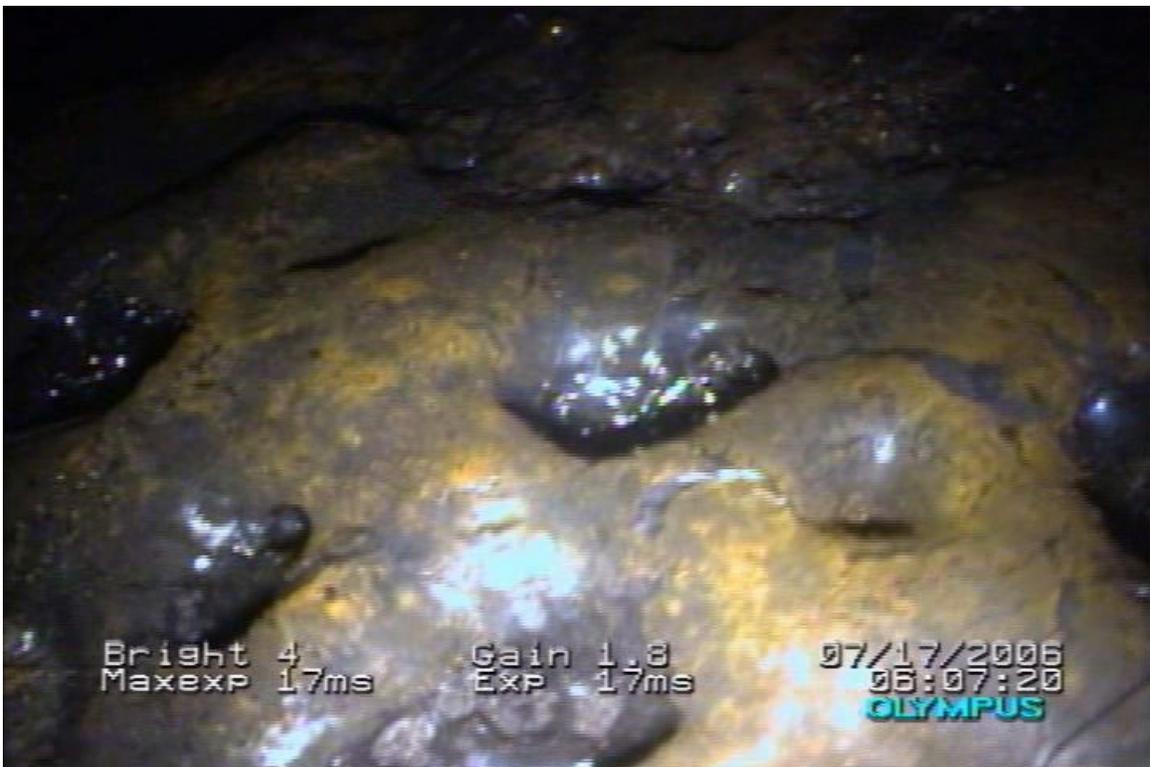
Figure 4.11 Close up view after Test 24, thick region

Figure 4.11 and Figure 4.12 show two very different, but typical views of the slag surface. In the first picture, the slag is quite thick, though bumpy, and the CMC is not visible. In the second, the slag is in drops, with well defined edges, and the CMC surface is visible, including what appear to be edges of layers of fabric (confirmed in post test inspections). This is the upstream edge of the first cylinder, and these fabric edges were visible to the naked eye after disassembly.
