Downhole Technologies LLC

**Development of a Low-Cost
Rotary Steerable Drilling System**

Final Report

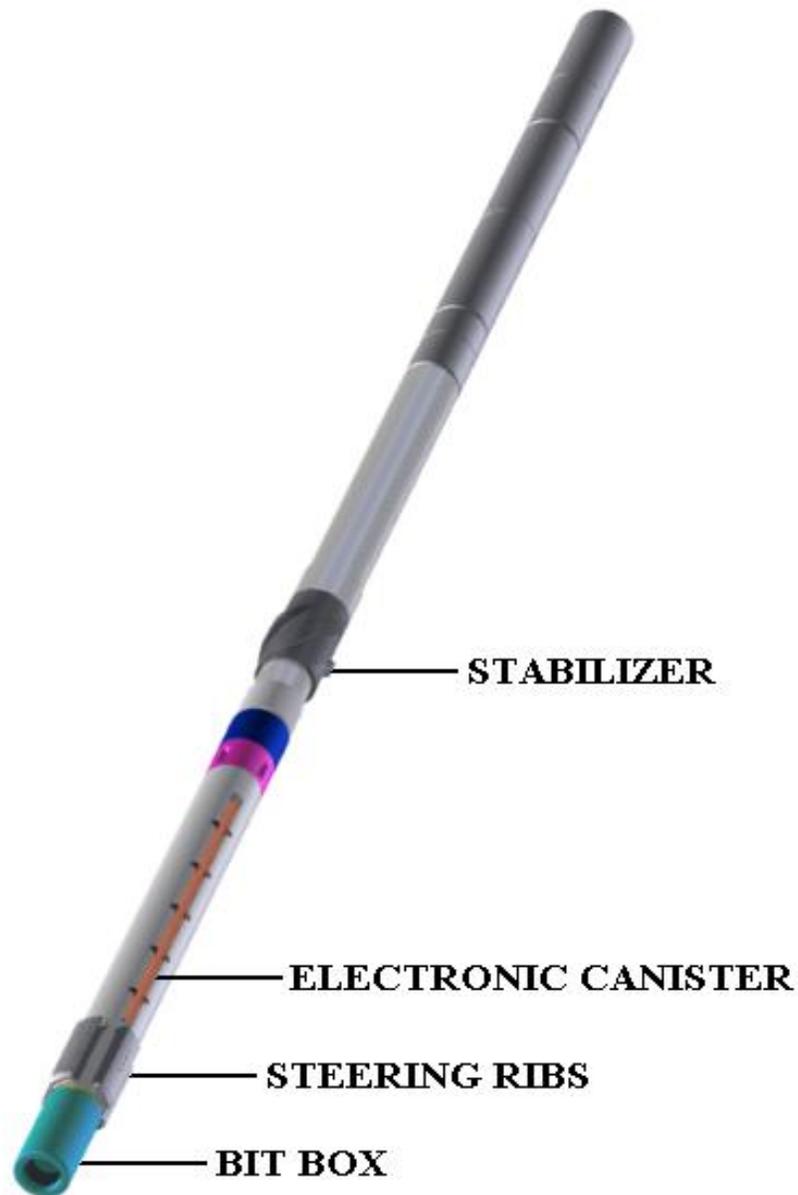
Figure 1. DBDHT 6 $\frac{3}{4}$ in. LCRSS

Diamondback / SERVAgrou Downhole Technologies, LLC Low Cost Rotary Steerable System (LCRSS) represented the latest generation, state-of-the-art design. The company's engineering team applied the "lessons learned" from past RSS development and testing activities to produce a new design that was significantly more robust and much less costly to build and service. The new LCRSS tool adopted a "plug and play" approach that allowed tool assembly and service to be accomplished 75% faster than predecessor systems. In addition, the new design had well under half the part count and had proven far more amenable to downsizing to a 4 ¾ in. tool size. This design is illustrated in the FIGURE 1 below. The additional proprietary re-design information may be obtained by contacting the Project Director.

- **Unitized 150°C Electronics** – All electronics resided inside a single 20,000 WPSIG pressure canister having one multi-pin booted electrical connector. This design minimized the number of soldered connections with none required except those made on the PCB board level.

- **Unitized Hydraulics** – Like the electronics, all hydraulic components including the system oil compensation resided in a single housing. This was in sharp contrast to prior design where the hydraulics was dispersed in multiple modules that required more complete mating requirements. The net result was a substantial reduction in costs, assembly time and most importantly, the elimination of a large number of O-rings and fasteners. The hydraulic canister was also rated for 20,000 WPSIG.

- **Top Loading Drive Shaft** – The LCRSS employed a top loading drive shaft that simplified the assembly. The drive shaft featured dual sets of radial bearings at the top and bottom sections along with intermediate radial bearings run in the immediate vicinity of the shaft-drive hydraulic pump. On- and off-bottom thrust bearings were also included reacting to weight on bit and tripping forces. Proprietary seal technology was used at the top and bottom of the shaft/housing interfaces to prevent communication between the shaft oil and drilling mud.

- **Closed-Loop Operation** – The LCRSS was a 4-piston, closed-loop push-the-bit system. The closed loop control eliminated the need for a high level of operator training and optimized the rate at which given sets of target coordinates were obtained. Additionally, closed-loop assured a high level of fidelity (reduction in vertical and horizontal wander) once the target objectives have been met.

Borehole Size	8 ½ in. – 9 5/8 in.
Build Rate	9°/100 ft.
Bit Connection	4 ½" API regular
Top End Connection	4 ½" XH
Maximum Flow Rate	600 GPM
Minimum Flow Rate	300 GPM
Maximum WOB	56,000 lbs.
RPM Range	50 – 200 RPM
Maximum Bit Torque	17,700 ft-lbs.
Maximum Operating Temperature	150° Celsius
Maxim Pressure	17,500 psi
Angular Accuracy:	
Azimuth	±0.3°
Inclination	±0.1°
Roll	±0.1°

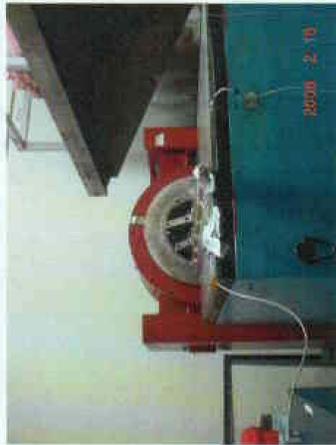
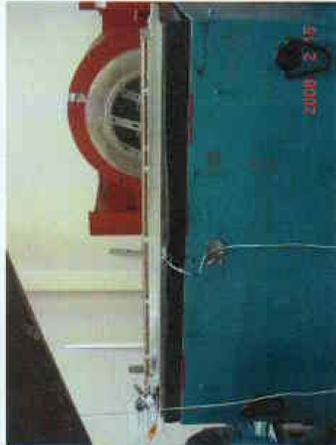
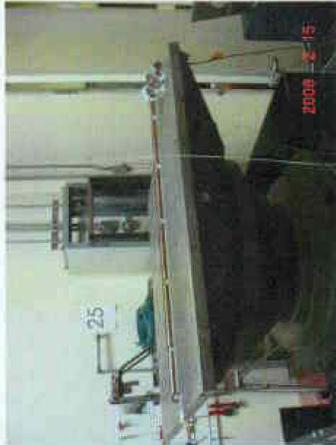
Random Vibration Test

X-AXIS

Y-AXIS

Z-AXIS

JOB NO. : QL-08-103 10-1000 HZ @ 5 G rms

Prior to the commencement of field tests, the tool electronics were subjected to a series of thermal (155°C ramp/hold/ramp) and vibration tests (5 G and 15 G rms random ½ sine, 10 – 1000 Hz all axes) during January and February 2008. These tests were conducted with the electronics packaged exactly as they are normally housed for the down-hole environment. The electronics successfully passed these tests and allowed DBDHT / SGDHT to start field test activities. The Quanta Laboratories reports, included in Attachments A and B, illustrates the test hardware and typical frequency profiles for the random vibration tests.

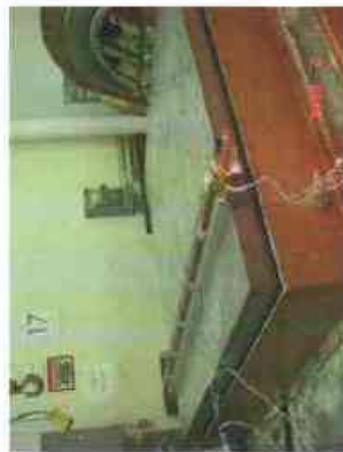
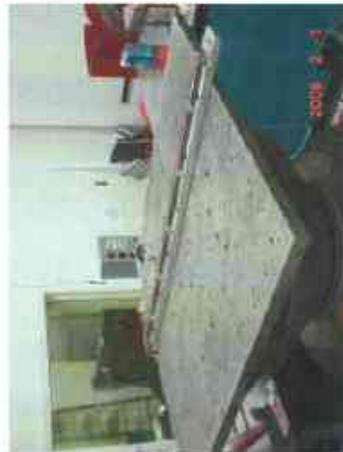
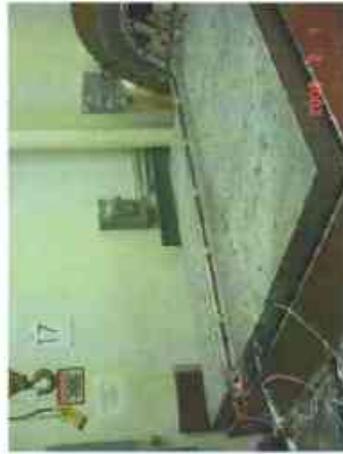
Random Vibration Test

X-AXIS

Y-AXIS

Z-AXIS

JOB NO. : QL-08-103 10-1000 HZ @ 5 G rms; 15 G rms
